Manhole Inspection Summary

Manhole # S21W__032MH

Insp Date: **11/11/08 1:51 PM**

Location Address: **1927 HOLLINS FERRY RD**

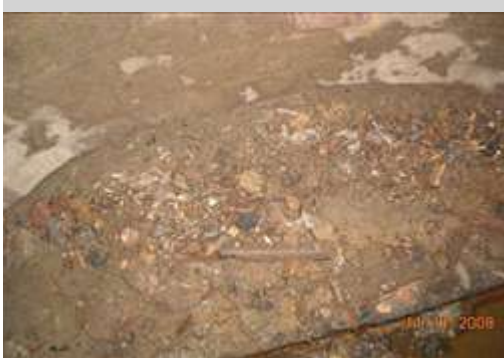
Defect 1

Condition: ☐ Sound ☐ Cracked ☐ Root Intrusion ☐ Deteriorated ☐ Leaks ☒ **Debris**

DEBRIS ON BENCH

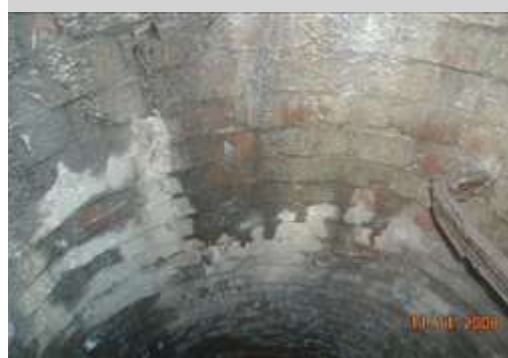
Defect 2

Infiltration: ☐ None ☐ Joint ☐ Cracks ☐ Mortar ☐ Roots ☒ **Wall**

Steps Count: **4** Missing: **0** ☒ **Corroded**

INFLOW FROM SHEETING, corbel flow wall, corroded step

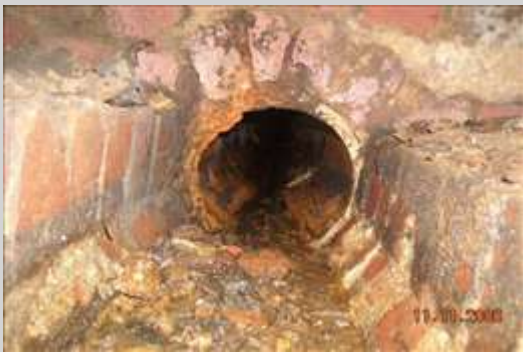
12 O'Clock Outflow

8 in. Circular Gravity Sewer
Pipe Out @ 12 O'Clock

Pipe Height: **8.4** (in.) Rod and Bar (Angled)
Pipe Material: **Clay** ☐ Pipe Lined
Invert Depth: **8.35** (ft.) Flow Characteristics: **Slow**
Deposits: ☒ None ☐ Mud ☐ Sludge ☐ Debris ☐ Grease
Silt Depth: **0** (in.) Deposits Extent:
Infiltration: **None** Pipe Seal Cond: **Sound**

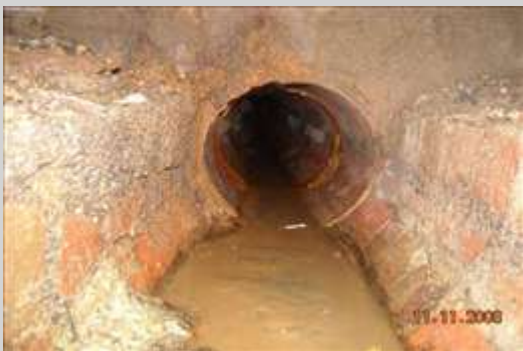
6 O'Clock Inflow

8 in. Circular Gravity Sewer
Pipe In @ 6 O'Clock

Pipe Height: **8.4** (in.) Rod and Bar (Angled)
Pipe Material: **Clay** ☐ Pipe Lined
Invert Depth: **8.30** (ft.) Flow Characteristics: **Slow**
Deposits: ☒ None ☐ Mud ☐ Sludge ☐ Debris ☐ Grease
Silt Depth: **0** (in.) Deposits Extent:
Infiltration: **None** Pipe Seal Cond: **Sound**
